REMEDIATION on North Dutch Island

Environmental expertise moved a project from investigation to remedial action in a single Alaska field season under two consecutive, yet distinct contracts.

By Monica Oakley, PMP

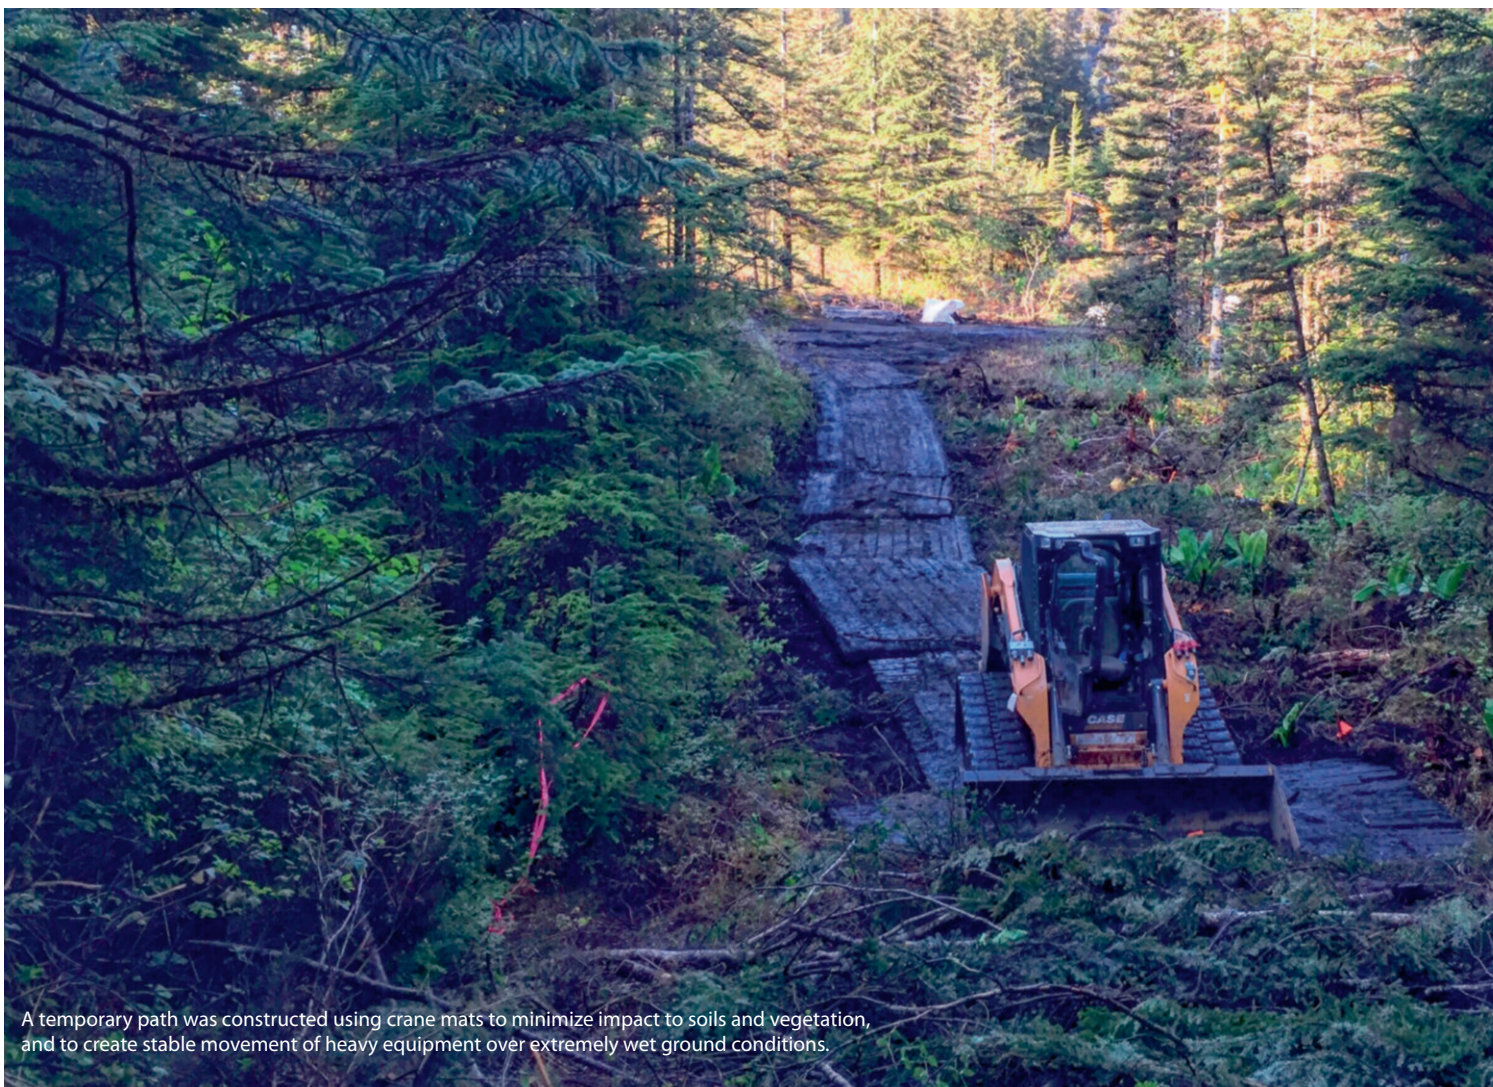
A temporary path was constructed using crane mats to minimize impact to soils and vegetation, and to create stable movement of heavy equipment over extremely wet ground conditions.

The use of lightweight crane mats to construct a temporary path for heavy equipment was proposed. Though still not ideal, the Forest Service and the U.S. Fish & Wildlife Service weighed all options and ultimately approved this solution. Mats were inspected to ensure no transfer of invasive species and the Forest Service walked the proposed pathway for mat placement to safeguard historical sites. With mats in place, Phase One moved forward.

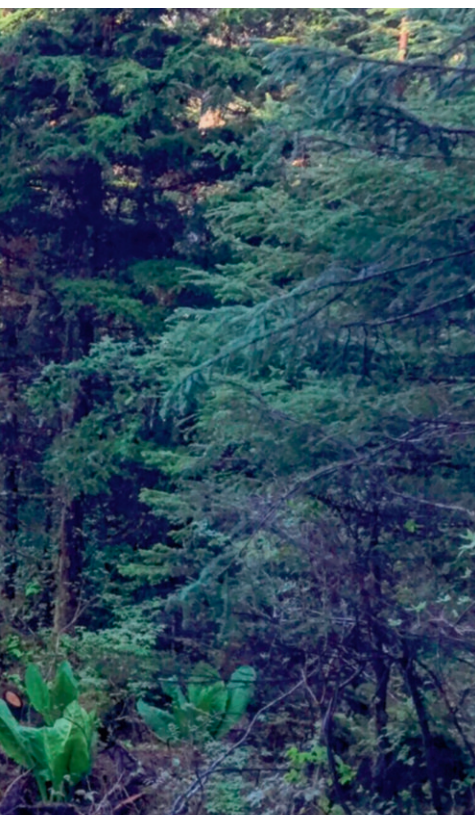
Excavated contaminated soils are placed in Super Sacks and barged offsite for proper disposal.

Approximately 256-T of contaminated soil was removed and transported offsite for disposal. Imported backfill was not an option due to the WSA designation and potential for introducing invasive species onto the island. Excavations were restored with existing beach gravel to original grade or re-sloped to prevent ponding of water and unsafe conditions.

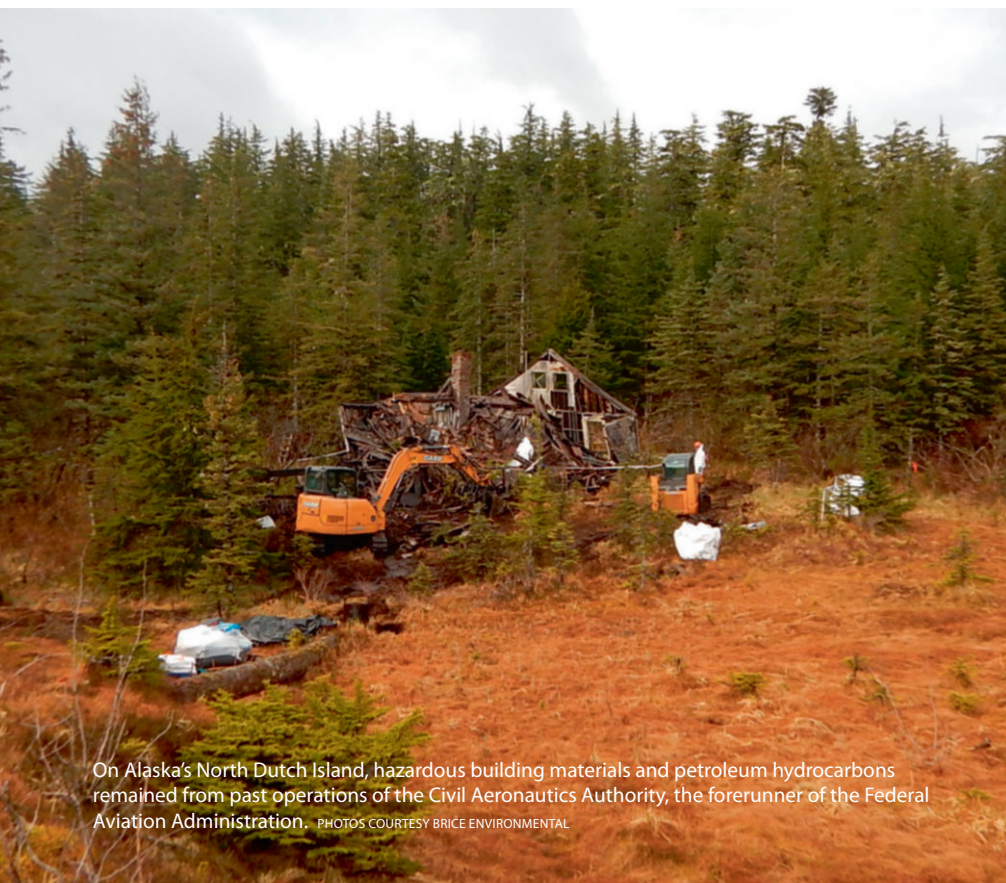
On Alaska's North Dutch Island, hazardous building materials and petroleum hydrocarbons remained from past operations of the Civil Aeronautics Authority, the forerunner of the Federal Aviation Administration. PHOTOS COURTESY BRICE ENVIRONMENTAL
